**DEPARTMENT OF TRANSPORTATION**

Contract #: 04-0120F4Cty: SF/ALA Rte: 80 PM: 13.2/13.9File #: 1.28**WELDING INSPECTION REPORT****Resident Engineer:** Casey, William**Address:** 333 Burma Road**City:** Oakland, CA 94607**Report No:** WIR-029464**Date Inspected:** 04-May-2013**Project Name:** SAS Superstructure**OSM Arrival Time:** 700**Prime Contractor:** American Bridge/Fluor Enterprises, a JV**OSM Departure Time:** 1530**Contractor:** American Bridge/Fluor Enterprises, a JV**Location:** Job Site**CWI Name:** Bernie Docena**CWI Present:** Yes No**Inspected CWI report:** Yes No N/A**Rod Oven in Use:** Yes No N/A**Electrode to specification:** Yes No N/A**Weld Procedures Followed:** Yes No N/A**Qualified Welders:** Yes No N/A**Verified Joint Fit-up:** Yes No N/A**Approved Drawings:** Yes No N/A**Approved WPS:** Yes No N/A**Delayed / Cancelled:** Yes No N/A**Bridge No:** 34-0006**Component:** SAS Tower**Summary of Items Observed:**

**In Process Visual Inspection**

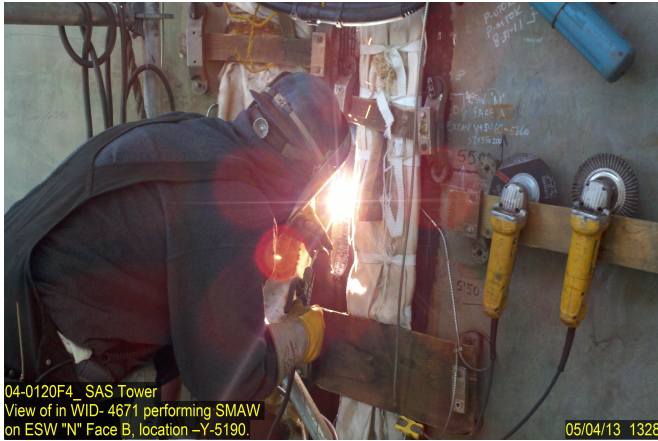
The QA Inspector observed, at random intervals, ABF/JV welder Mike Jimenez (WID-4671) performing weld repairs of the R2 repair excavation on Electroslag Weld (ESW) "N", at face B original Y location 5190mm.

Locations are listed as detailed in Request for Weld Repair (RWR) 201304-013 from Ultrasonic Testing indications designated for repair. Prior to the repair work, ABF Quality Control (QC) Inspector Bernie Docena and the QA Inspector performed a preliminary MT verification of in-process weld passes to verify the weld was clear of any discontinuities that may have occurred during cooling overnight. The repair area will be reinspected after welding any indications noted will be reevaluated. The welder was observed preheating the weld to over 300° Fahrenheit prior to welding using the Miller ProHeat 35 with heat induction blankets. The welder utilized ABF Welding Procedure Specification (WPS) ABF-WPS-D15-1000-Repair Rev.3 for Shield Metal Arc Welding (SMAW). The welding parameters were verified by QC Inspector Bernie Docena throughout the day and appeared to be in compliance with the WPS noted above. See TL-6028 for information on items inspected.
